HiLine Property Inspections LLC DBA National Property Inspections

Property Address, Shelby, MT, 59474

Monday, March 28, 2022

GENERAL INFORMATION

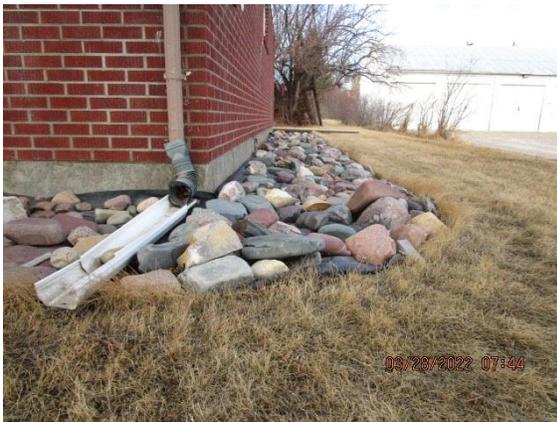
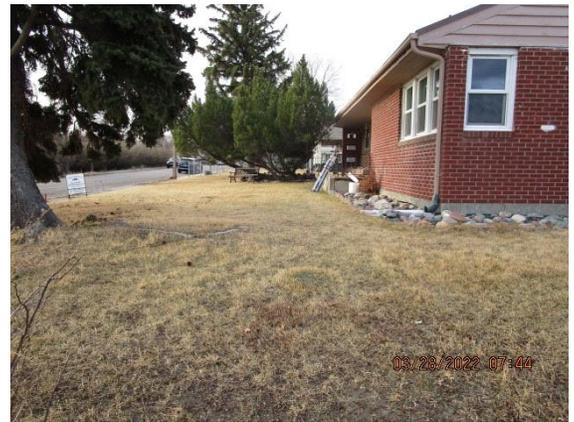
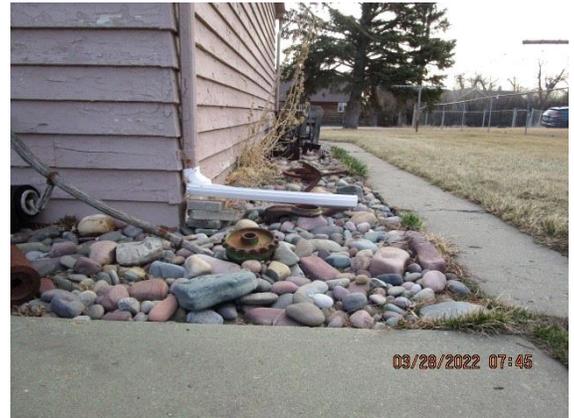
Negative to flat drainage observed around property. Recommend building up grade to ensure water drains away from foundation.

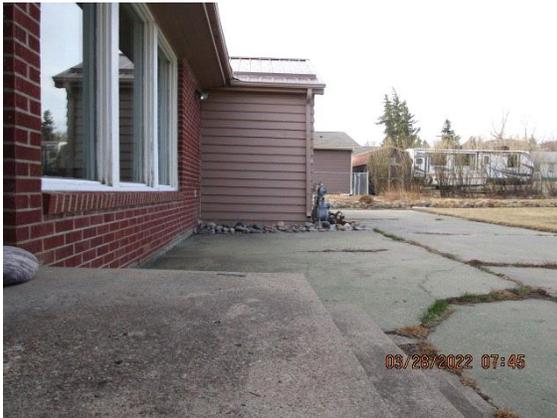
Grading / Drainage: Negative slope at back patio

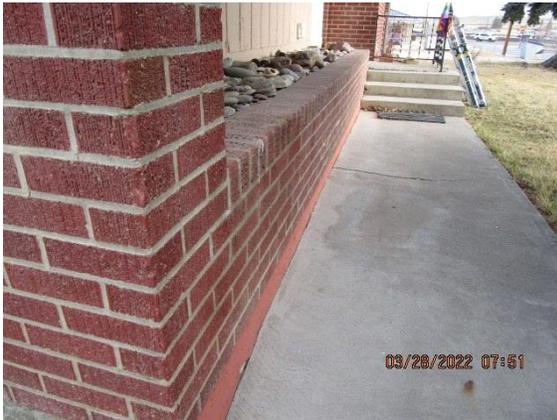
Retaining wall appeared to be functioning as designed and is in good shape at time of inspection.

Retaining Walls: Front planter/retaining wall.

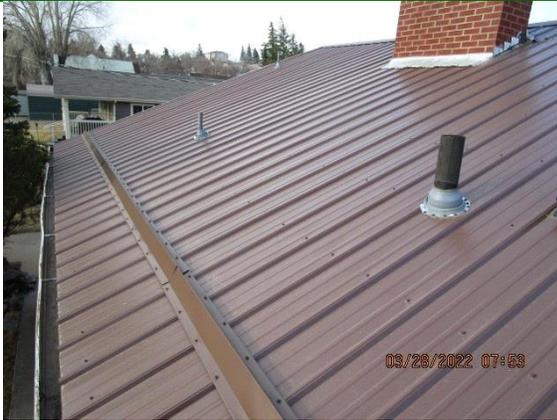
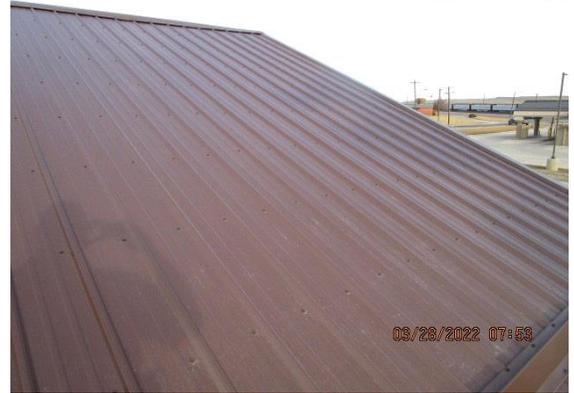
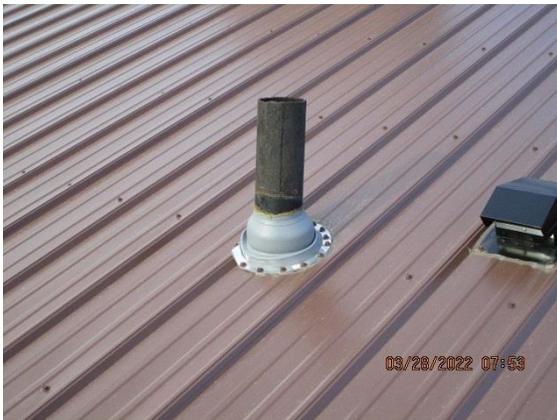
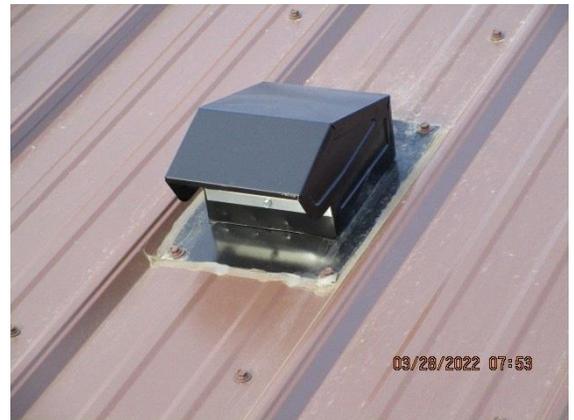
The overall condition of the roof covering was in acceptable conditions. No evidence of leaks or hail damage at time of inspection.

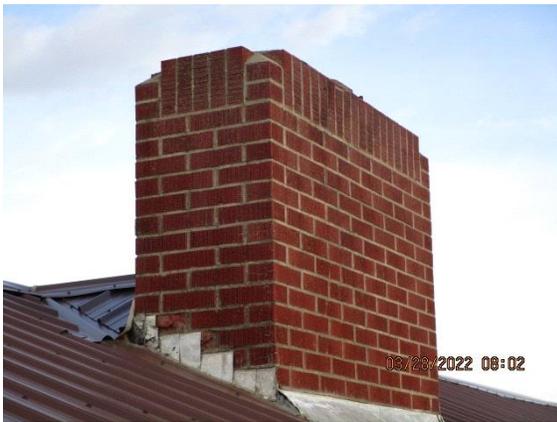
Chimney:

The overall condition of the chimney was in good condition with exception of no rain cap present. Recommend repair/evaluation by qualified person(s).

Flue not inspected. Annual cleaning is recommended.

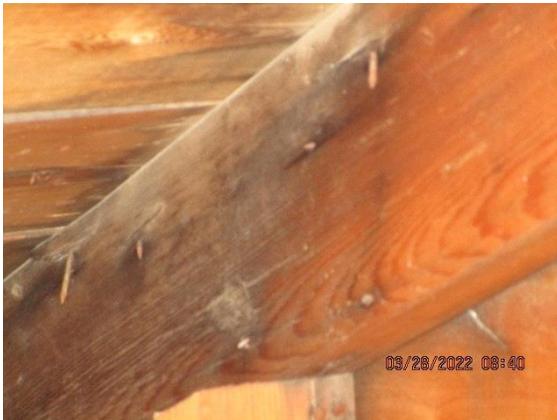
There was light evidence of past water intrusion however there is no current indication of any current leaks from the roof at time of inspection.

Attic Framing/Sheathing: Garage attic space with limited visibility. Evidence of past water intrusion.

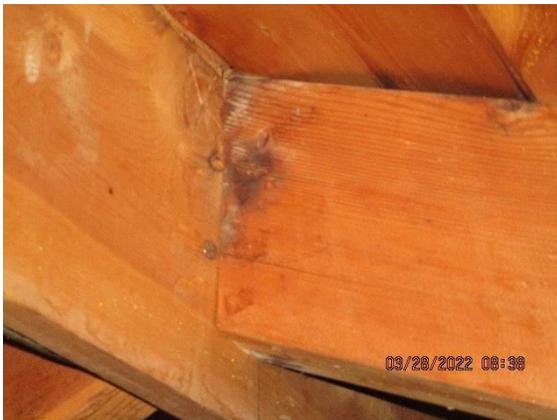
Attic Framing/Sheathing: House attic. Evidence of past water intrusion. Does not appear to be any new leaks with new roof installed.

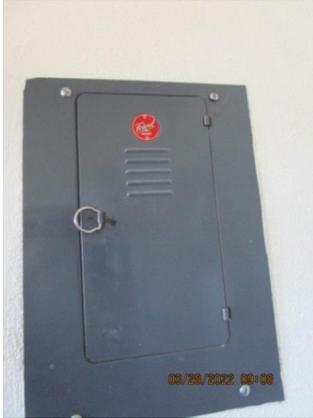
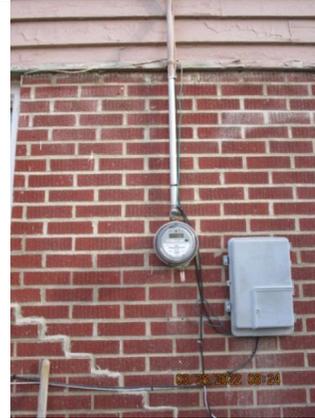
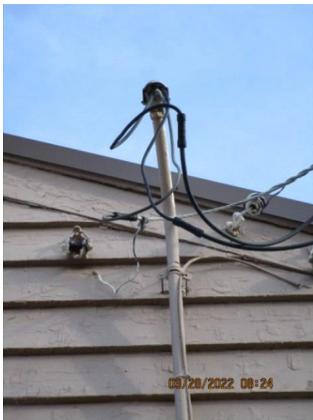
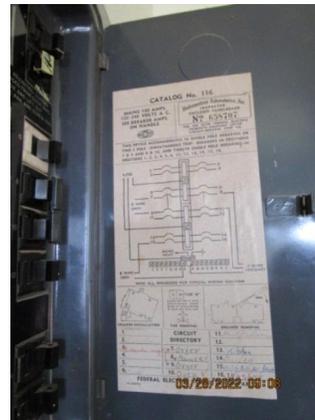
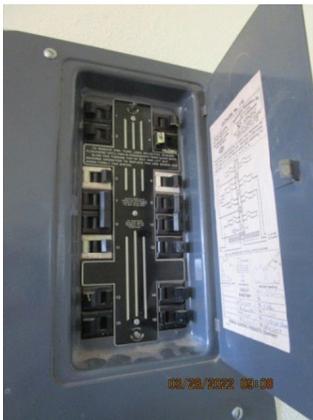
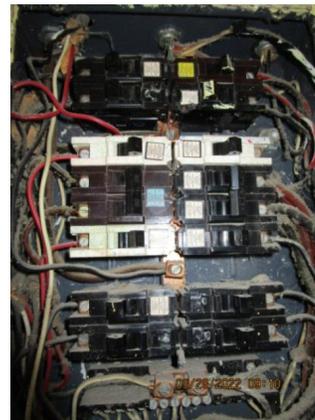
Electrical service was provided by a 60-Amp meter base. Sub panel is 100 amp. This is insufficient to meet most homeowners electrical needs. Some insurance companies may require the electrical service be upgraded to 100-Amp or more within 30 to 90 days of closing, as a condition for insurance coverage. Consult with your insurance company regarding their policy on 60-Amp service prior to escrow. The main electrical shut off is in the sub panel in the laundry room.

Older 2-prong outlets were noted during the inspection of this property. For improved electrical safety, properly grounded three-prong outlets should be installed in the kitchen, bathroom, garage, outside, and wherever newer grounded appliances with three-prong plugs are to be used.

GFCI (Ground Fault Circuit Interrupter) outlets help reduce the risk of electrical shock. GFCIs detect a change in current between the "hot" and "neutral" wires and trip the circuit, shutting off power to the circuit. No GFCI outlets were found during inspection. Recommend installing GFCI outlets in kitchen, bathroom and on all outdoor outlets. All smoke detectors were older than 10 years old. Recommend installing new smoke detectors within 12 feet of bedrooms.

No CO detector was found. Recommend installing CO detector within 12ft of bedrooms.
